St Simons Church, Putney

Site Inspection Notes - 31st January 2024

Wednesday, 31 January 2024

St Simon's Parish

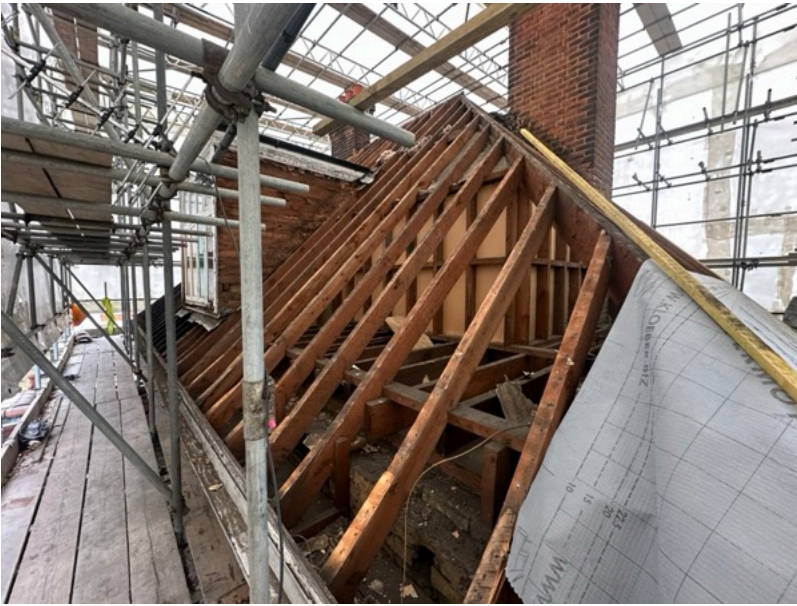
Photo 1

Overview of stripped roof. Roof timbers generally appear sound.

Woodland to advise if any rotten sections located.

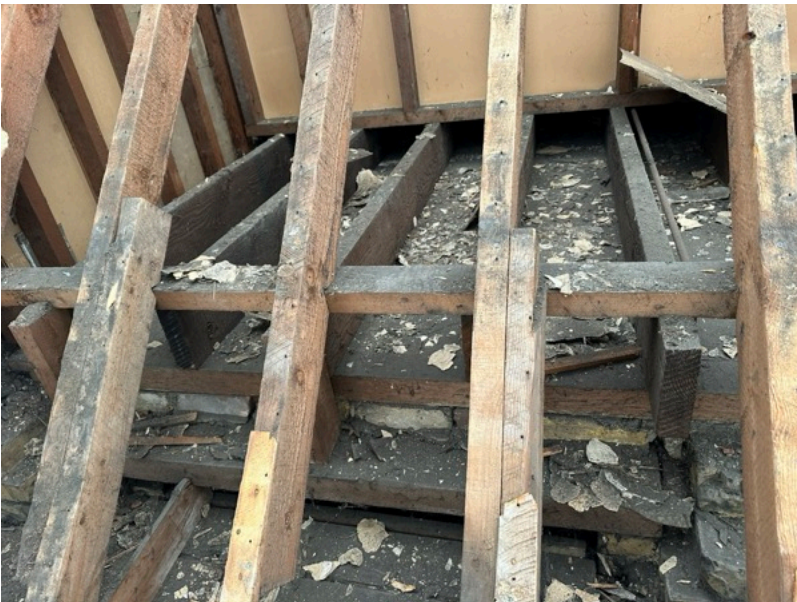
Photo 2

Previous insulation to the loft space cleared. New insulation to comply with Building Regulations to be installed.

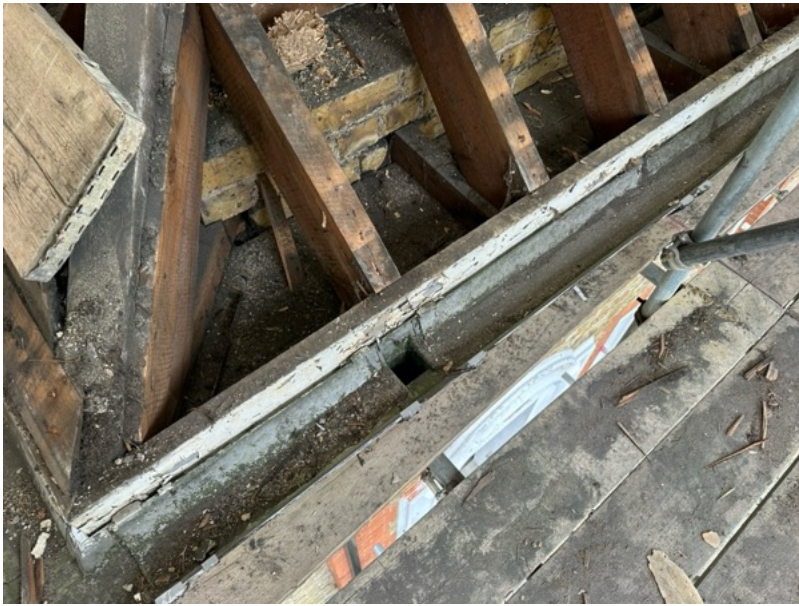
Photo 7

Timber fascia board generally appears sound. Retain, fill, and decorate. Any rotten sections can be cut out and replaced with same thickness timber.

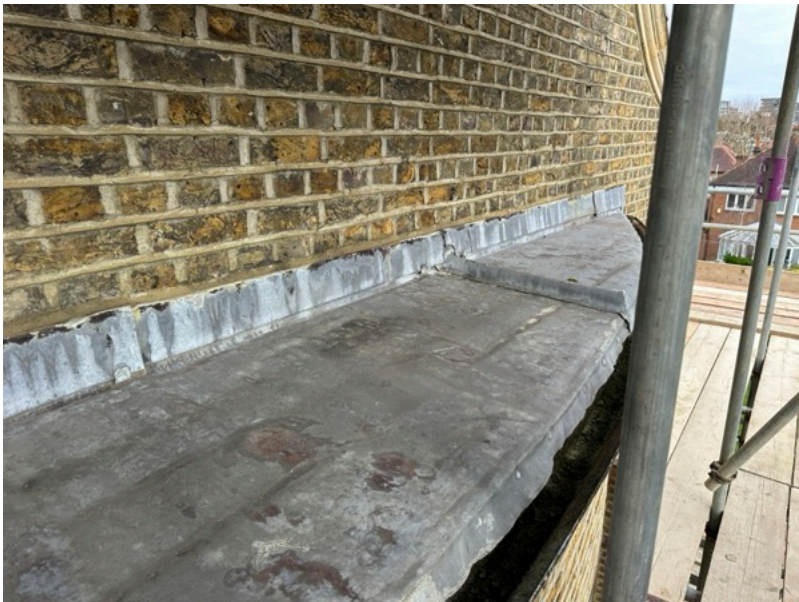
Photo 8

Lead covering to rear bay window found to be in fair condition. Apply patination oil to roof and hammer down lead where lifted or out of shape.

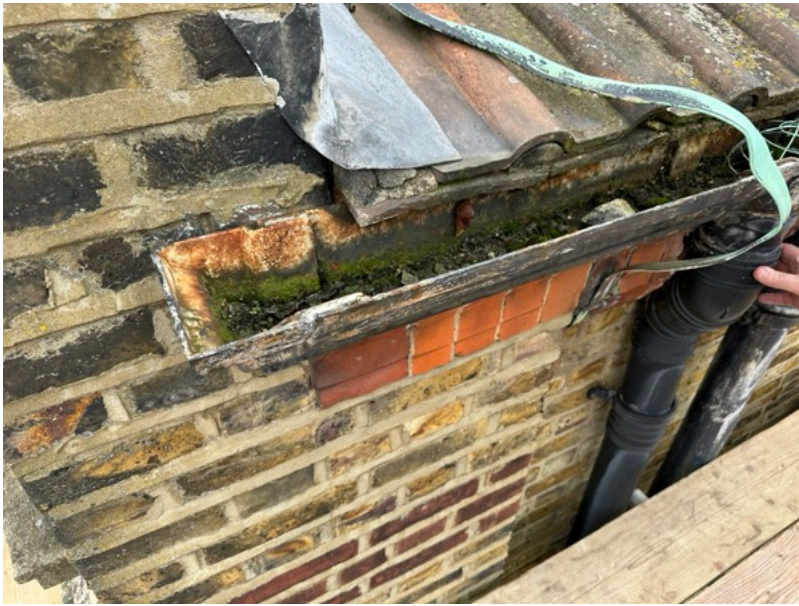
Photo 9

Cast iron gutters in fair condition. Clear out, seal internally and redecorate. Water test and replace any cracked or defective sections, but look to maintain original gutter wherever possible.

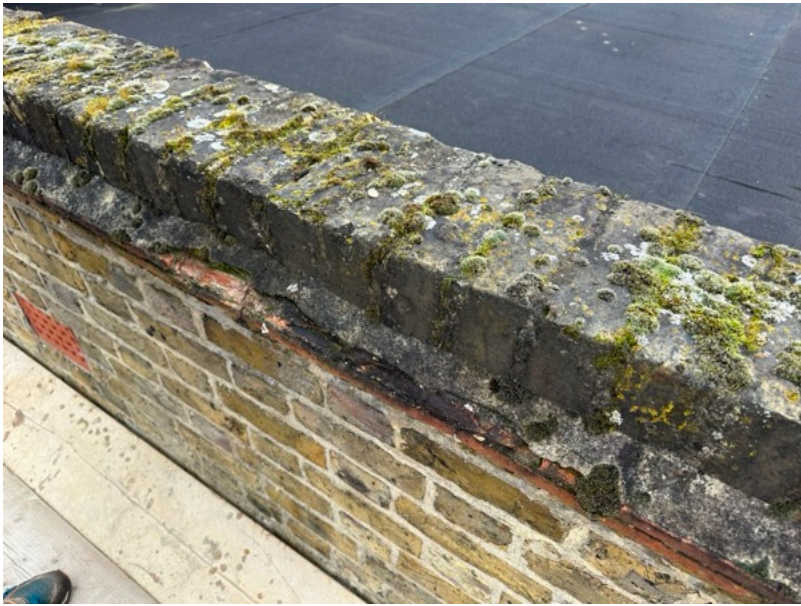
Photo 13
Location: Church (East Elevation)
Comment as per photo 12.

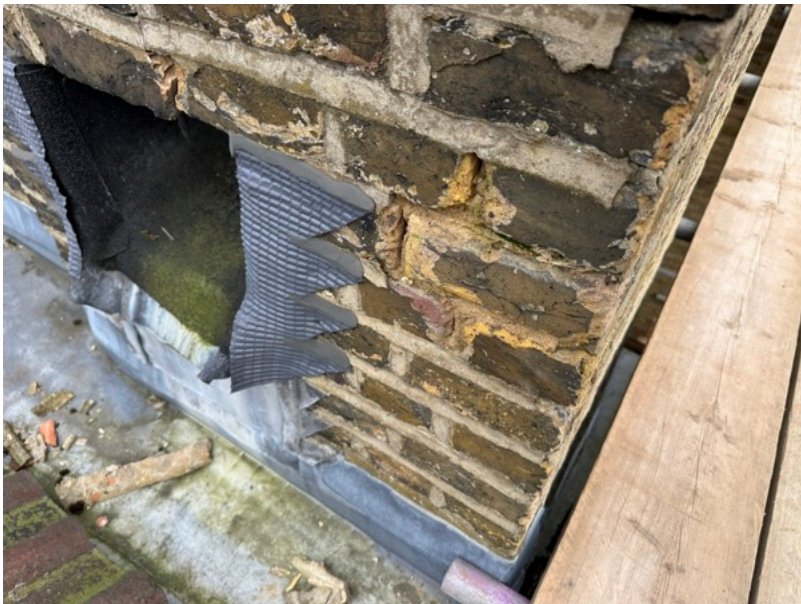
Photo 14
Location: Church (East Elevation)
Repoint all eroded and missing mortar
pointing around the hopper outlet to the
tower roof.

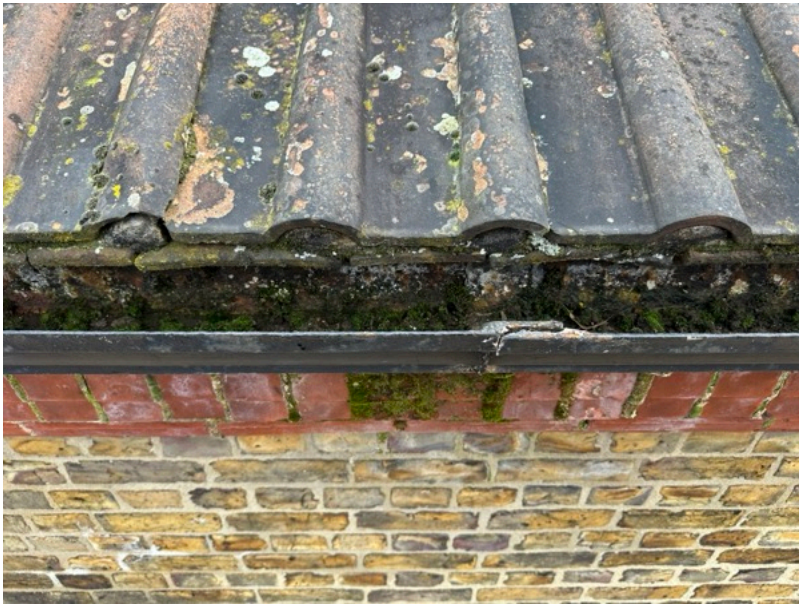
Photo 15

Cast iron gutters in fair condition. Clear out, seal internally and redecorate. Water test and replace any cracked or defective sections, but look to maintain original gutter wherever possible.

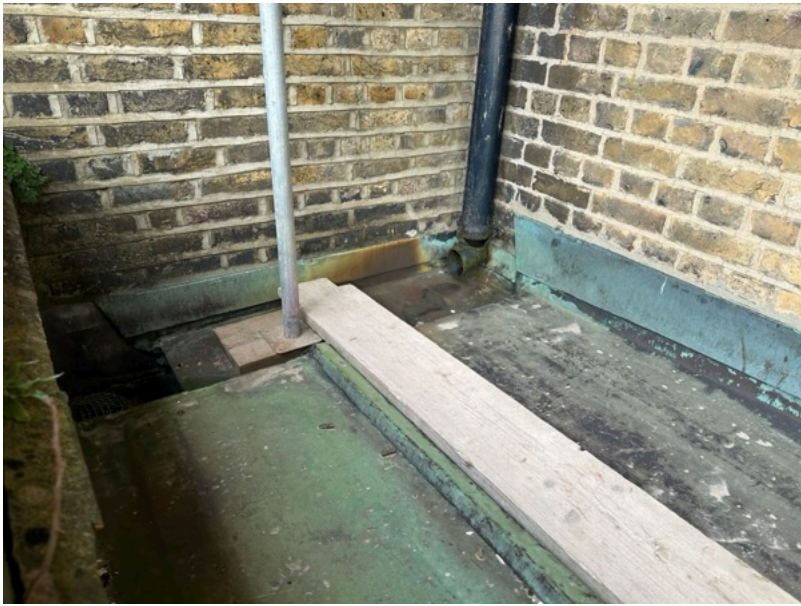
Photo 23
Location: Church (West Elevation)
Replace damaged shoe to rainwater
downpipe.

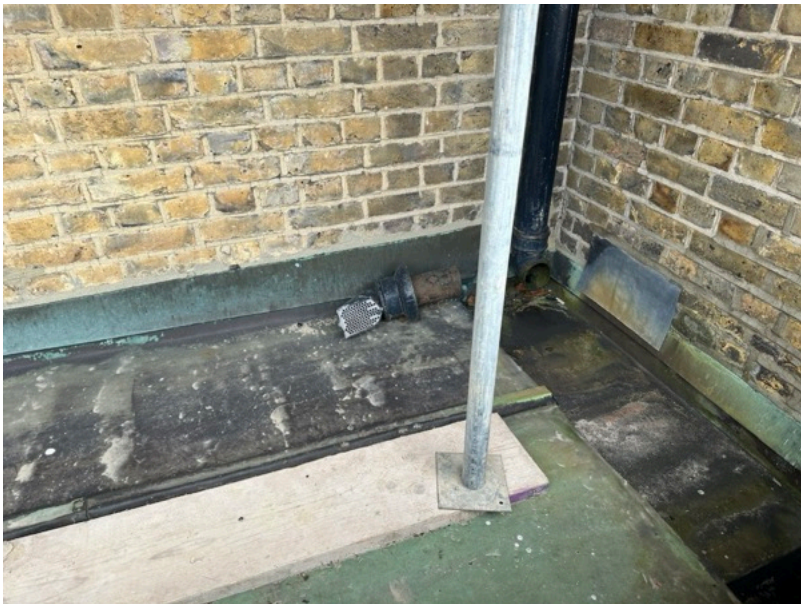
Photo 24
Location: Church (West Elevation)
Reuse redundant shoe to fix downpipe in
photo 23
